Conservation that works: projects outlast floods

June 2012 flood recovery effort

Progress to date in Southern Minnesota

August 2013

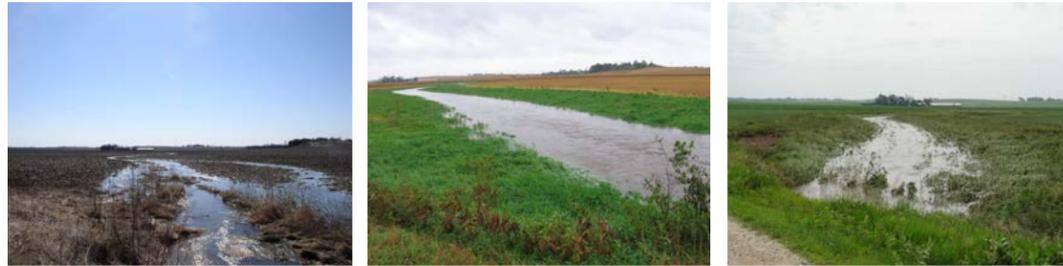
The Dakota SWCD worked with a landowner in Douglas Township (located three miles north of Cannon Falls) in 2009 to install a grassed waterway and establish native plantings along Conservation Reserve Program (CRP) acreage. The upstream watershed is approximately seven square miles and special engineering considerations were considered during its establishment in 2009.

In September of 2010, and after almost two full growing seasons, the area experienced more than five inches of rain in a 24-hour period. The grassed waterway and vegetation did exactly what it was intended to do – hold the soil in place.

During the June 2012 flood event of more than 10 inches of rain in a 24-hour period, the constructed waterway and adjacent CRP buffer again held as intended and saved tons of topsoil within the landowner's property.

From left: (pic 1) Prior to project installation, (pic 2) project following September 2012 flood, (pic 3) project after 2012 floods.

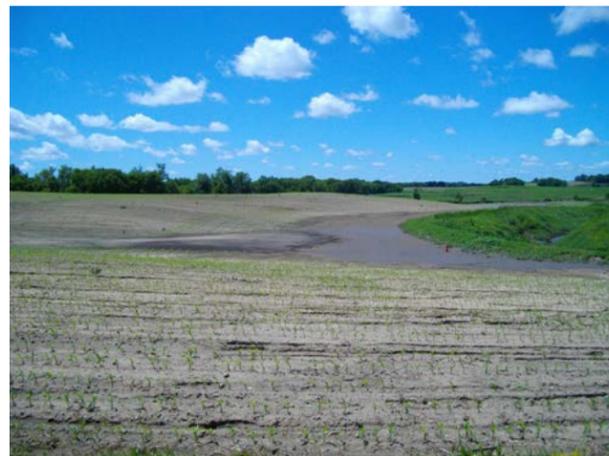
This is a water and sediment control basin that held up during the June 2012 rains, as sediment did not make it into the ditch.

Though the basin performed as designed, a large amount of sediment did accumulate during the storms. If the sediment is not cleaned out of the structure, the structure loses its capacity to hold back the next rain event.

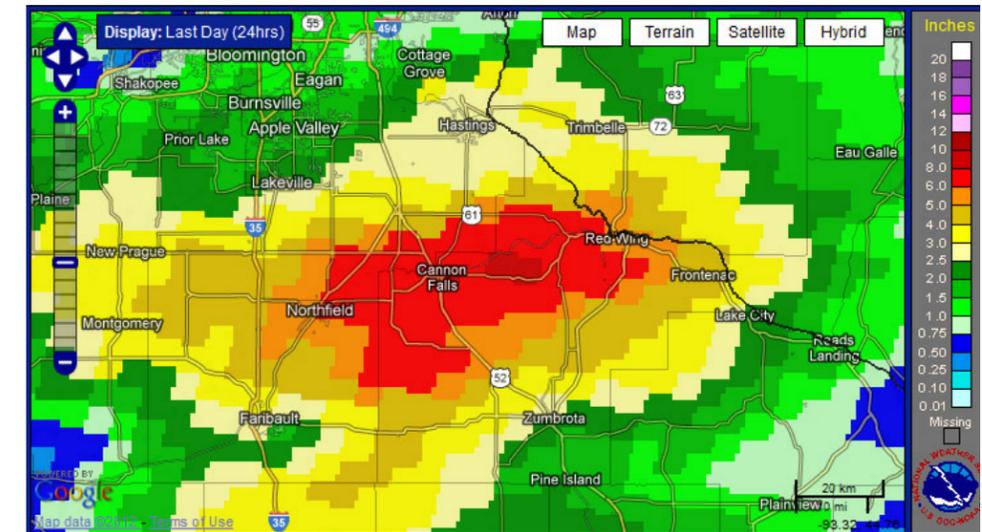
June 14-15, 2012 flood event rainfall totals: Southern Minnesota

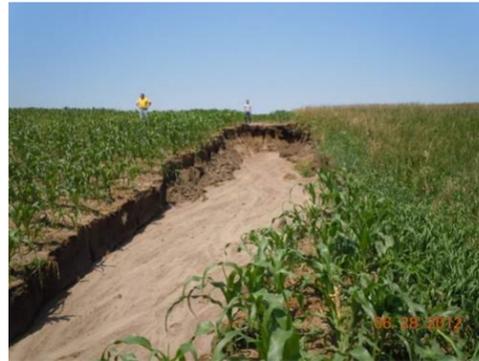
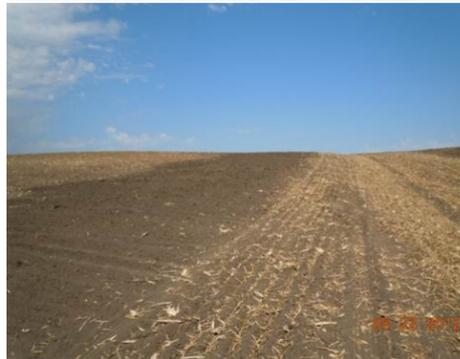
In the pictures at left, a 10-foot wide, three foot deep and 250 foot long gully on each side of an existing grassed waterway formed during the June 2012 storms in Dakota County.

From top: (pic 1) A massive gully formed following June 2012 storm, (pic 2) A grassed waterway was constructed and seeded down to correct erosion. (Picture prior to vegetation established.)

To correct the gully erosion, a 400-foot grassed waterway was constructed. Grass waterways are designed to prevent soil erosion while draining runoff water from adjacent cropland. As water travels down the waterway, the grass vegetation prevents erosion that would otherwise result from concentrated flows. Grass waterways also help prevent gully erosion in areas of concentrated flow. In addition on this site, a 16-acre native prairie planting was established to reduce risk of waterway failure in the future.

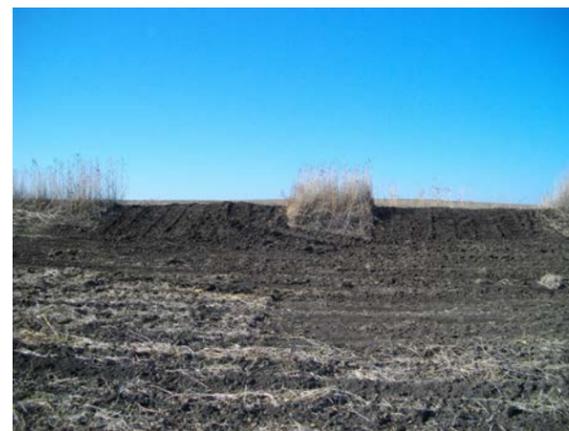
Rice County has a large number of water and sediment control basins, and all of the \$50,000 emergency allocation was utilized to repair basins. A total of eight contracts were executed, repairing a total number of 81 basins.

Repairing one basin costs approximately \$1,500.

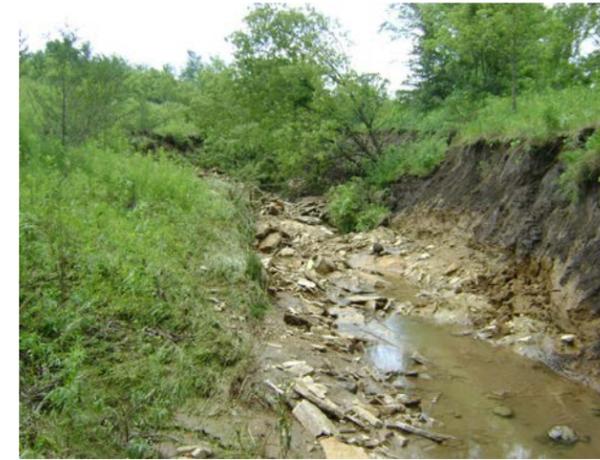
Picture: The lower end of the dam's emergency spillway is littered with debris from the storm.

During the June 2012 flood, a dam failed on a private property in Cannon Falls, causing more than 2,000 cubic yards of material to erode from the spillway. The storm also caused damage to the landowner's driveway and property downstream. The driveway repair and debris cleanup were started last summer to allow for access to the property, and the dam repair is slated to be completed in the summer of 2013. The landowners have partnered with the SWCD and the NRCS on this project for both financial and engineering assistance.

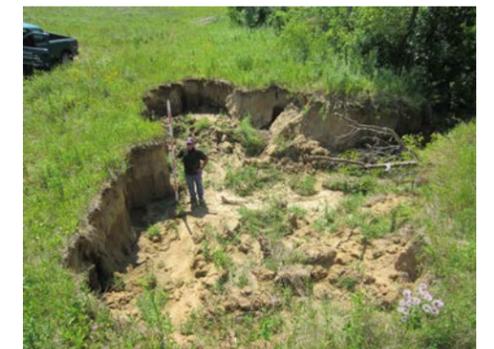
Active gully erosion formed within Dakota County Miesville Ravine Park Reserve during the June 2012 storm (pictured at right). Repair to this site will take place in 2013, including excavating unstable areas, placing compacted fill materials and re-establishing permanent vegetative cover using erosion control blankets and native seed mixtures. To prevent future gullies at this location, a permanent grade stabilization structure with reduced flow rate outlet will be constructed. Project partners assisting the Dakota Soil and Water Conservation District include Federal Emergency Management Agency (FEMA), Minnesota Board of Water and Soil Resources, Metropolitan Conservation Districts Joint Powers Board and Dakota County.

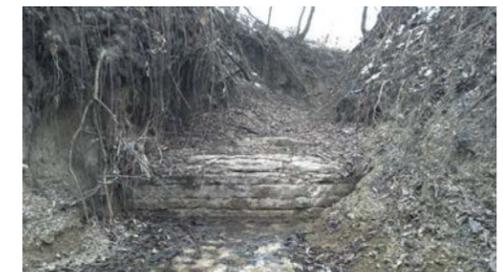
This gully pictured at right, along with three others, will be controlled with a grade stabilization structure (approx. 200 acre watershed) in spring 2013. Controlling runoff at this location in Rice County will also prevent flooding downstream for the City of Northfield.
