BWSR Snapshots

December 2012

NE MN June 2012 Flood Success Story: Knife River Clean Water Fund Streambank Stabilization Project By Ryan Hughes, Duluth Board Conservationist

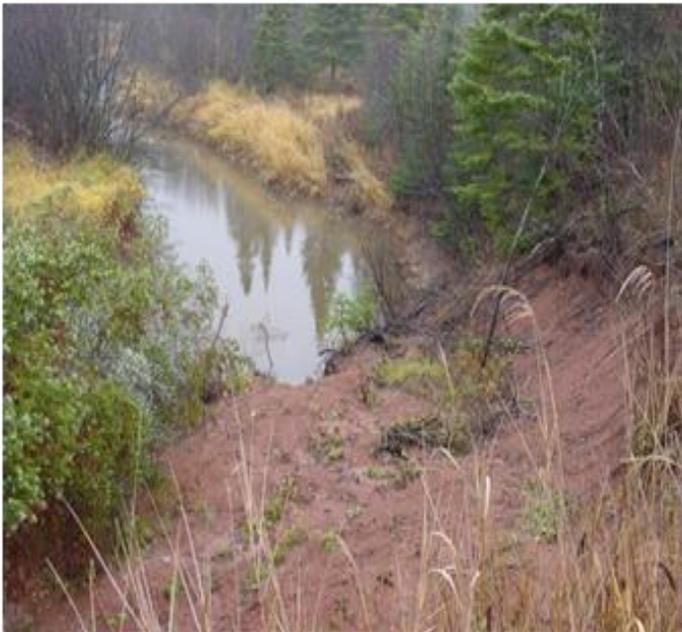
"Before" view of bank failure on the Knife River. Photo courtesy of South St. Louis SWCD (2011).

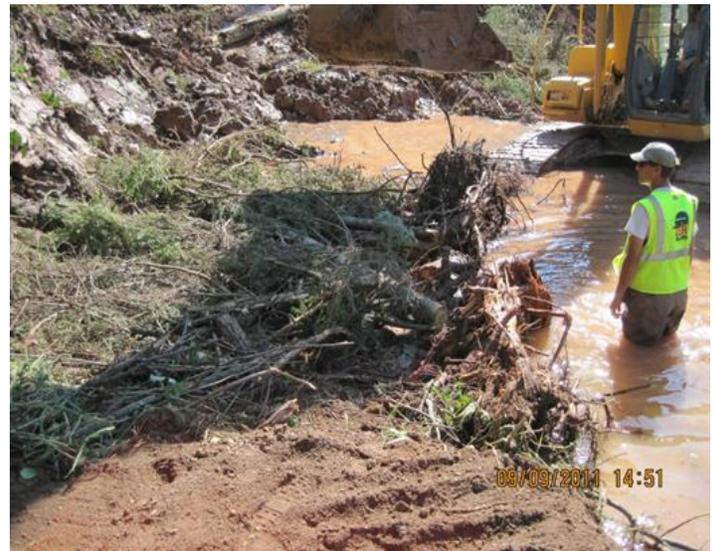
Floodplain shelf construction using layers of organic material as observed by the Area 3 SWCD JPB/TSA Engineer. Photo courtesy of South St. Louis SWCD (2011).

Through a BWSR Clean Water Fund grant, the South St. Louis SWCD cooperated with fifteen private and public partners to implement strategies to help restore the water quality of the Knife River and make progress towards delisting the river as an impaired waterbody. One project associated with the grant was an innovative streambank stabilization. The project used all organic materials, which included tree trunks, root wads, brush, clay, fine soil, and sod mats of willow, dogwood and alder, used as 'toe-wood' and placed in layers along the streambank with the help of some heavy equipment as seen in the photos.

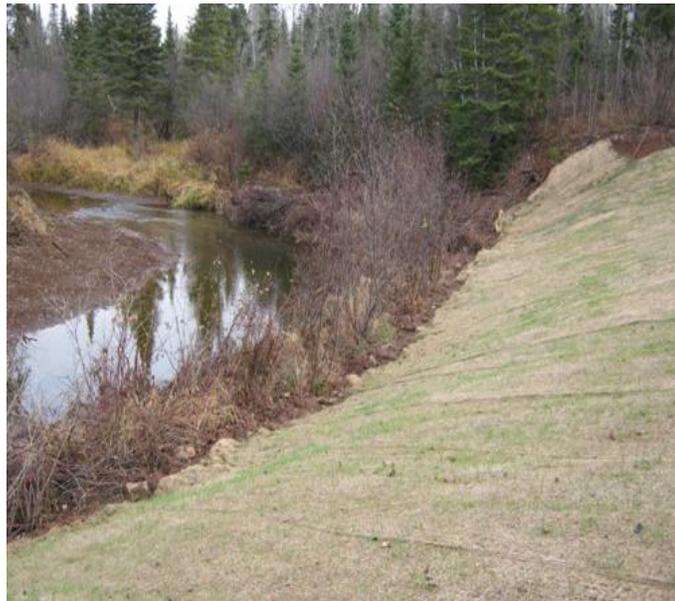
Project site post construction. Photo provided by BWSR Duluth office (2011)

Many implementation success stories have emerged following a post storm event assessment. One encouraging project was the 'toe-wood' project on the Knife River, which included the carefully engineered use of woody materials and native plantings. Not only did this project prevent erosion at the site during the 500-year rainfall event but it provides evidence that the use of organic materials in streambank stabilization projects can be successful.

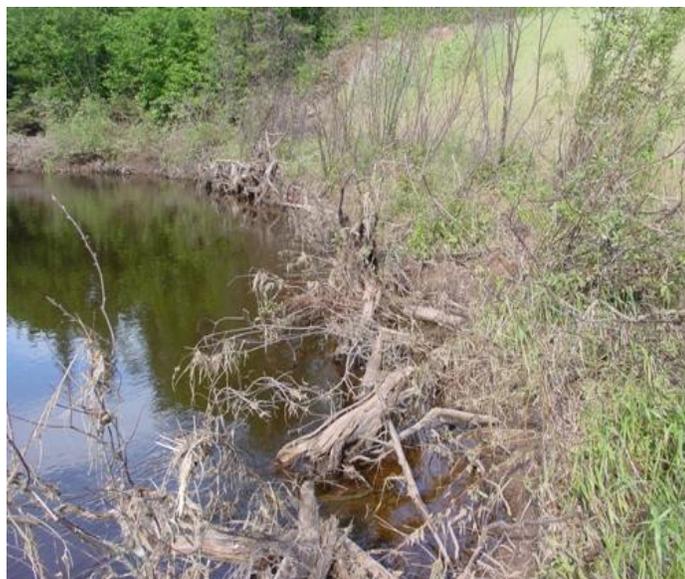
Project site following June 2012 storm event that delivered over 10 inches of rain in 24 hours. The project was not damaged as a result of the flood. Photo courtesy of South St. Louis SWCD (2012).

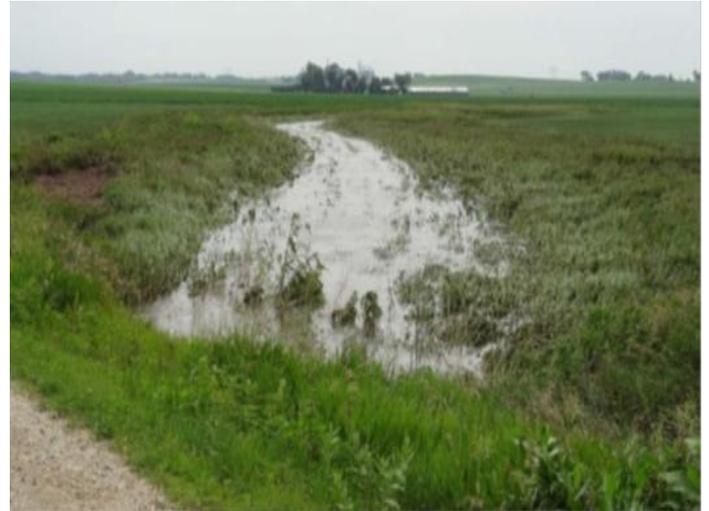
A waterway that functioned well under high flows. This waterway prevented soil erosion and filtered flood waters before they reached the river. Photos courtesy of Dakota SWCD.

In general, SWCD staff reported that existing conservation practices, such as grassed waterways, that were professionally designed and installed performed well and withstood the raging waters caused by over 9 inches of rain in less than 24 hours. In other cases where no waterway existed or was under-designed, gullies washed out fields and carried sediment and nutrients into streams.

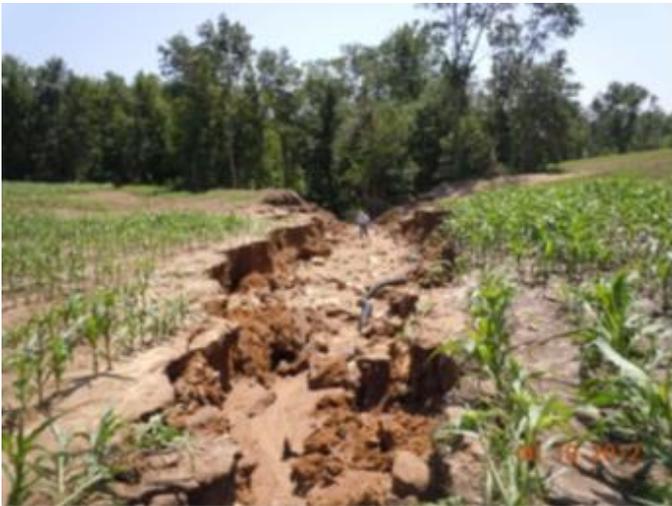
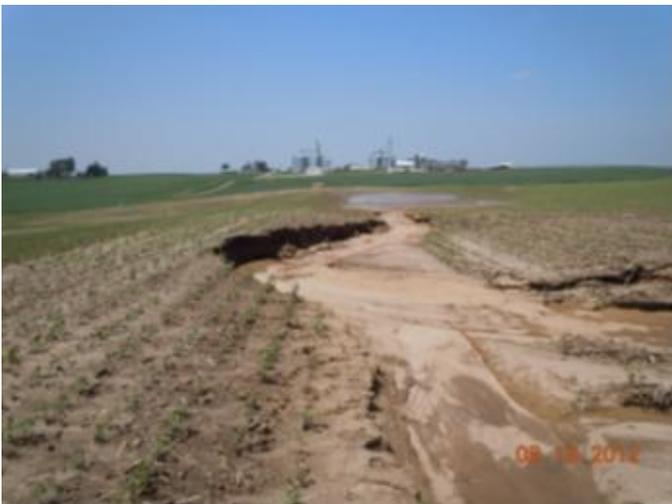
Typical large scale gullies in fields that did not have conservation practices installed.
