Sediment Reduction by Failing Structure Removal on Designated Trout Stream

Clean Water Funds: 2011

Carlton SWCD

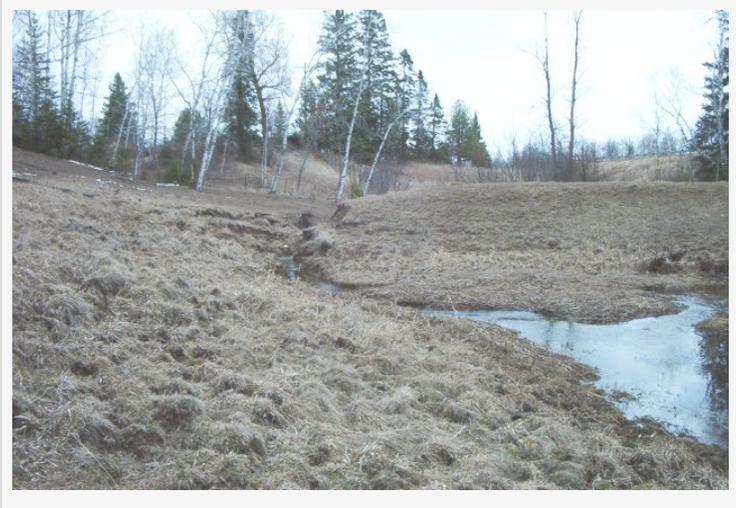
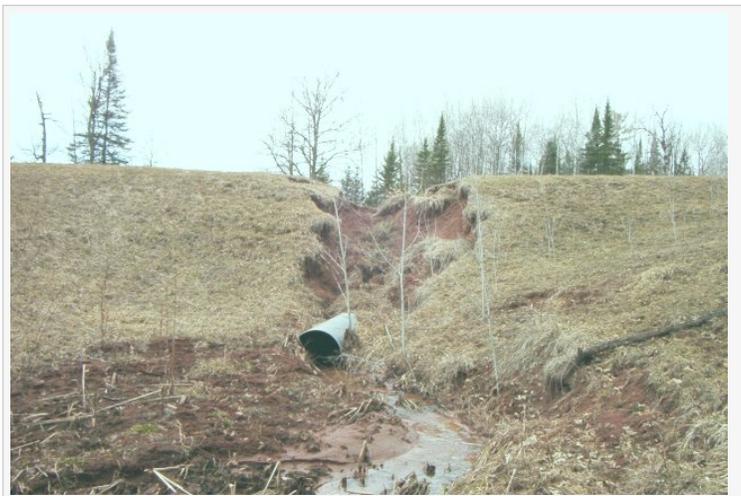
A failing structure

Three of the four structure sites in the Deer Creek watershed were assessed by a multi-agency team which found failed metal pipes and, in one case, a breached structure. Soil loss from this breached structure site is approximately 8775 tons, and will continue to increase as the channel seeks to stabilize itself. Potential soil loss from 2 other sites where the metal pipes are rusted out is 3,900 tons.
