# Clean Water Funds solve long-time problem in Pomme de Terre River

July 2013 Snapshots

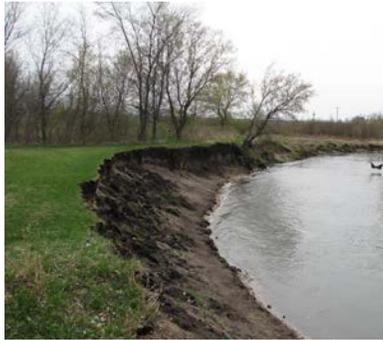
Every year, more than 115 tons of soil was washing away from the banks of the Pomme de Terre River, adding that much sediment to the stream.

*From top: (Picture 1) Erosion has been a long-term problem below the south side of the dam at Pomme de Terre Park in Morris. (Picture 2) Four stream barbs were constructed along the Pomme de Terre River bank to divert flow into the center of the stream and prevent erosion on the banks. (Picture 3) The shoreline below the south side of the Mill Dam after stream barbs were installed and banks seeded. (Picture 4) Sign at site noting partners.*

Finally, with Clean Water Funds, a project was completed in 2012 to solve the erosion problems below the south side of the dam at Pomme de Terre Park in Morris, Minn.
