Pickwick Dam Emergency Outlet Repair and Streambank Stabilization

Featured Project

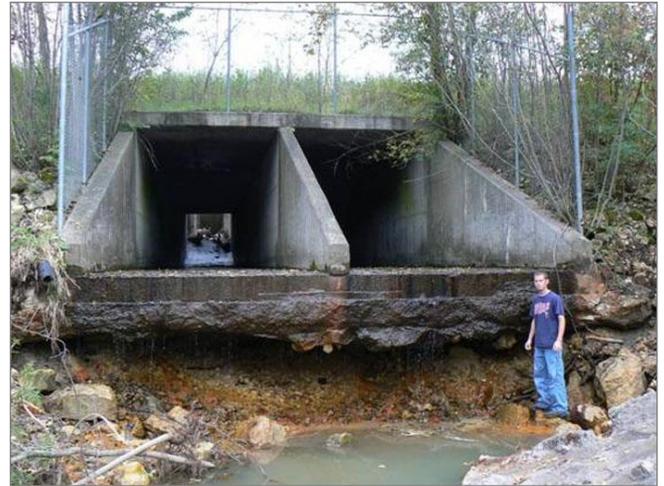
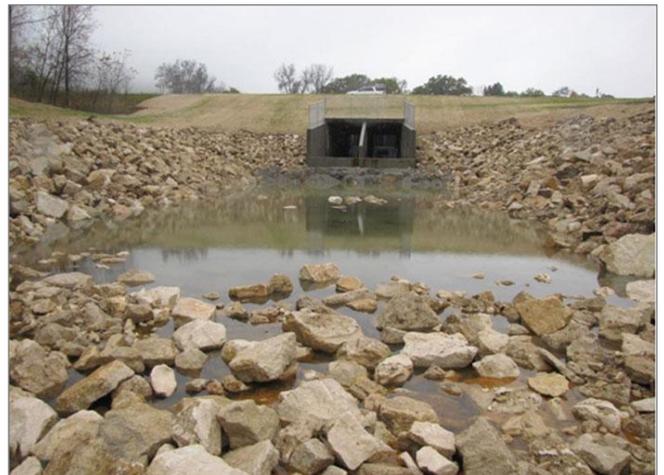
Before (top) and after photos of the Pickwick Dam Emergency Spillway Outlet.

Yaggy Colby Associates was hired by Homer Township to provide engineering assistance to repair the damage. The firm designed a large plunge pool lined with riprap, supplemented by downstream rock riffles and channel riprap lining. The project provides substantial energy dissipation to prevent outlet channel erosion.

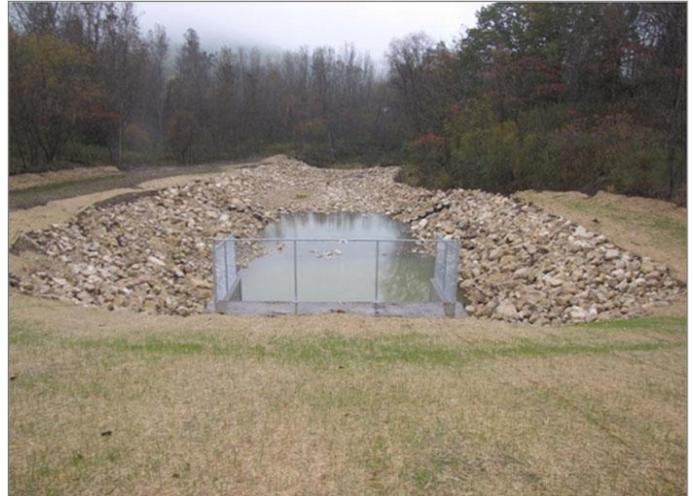
The Pickwick Dam emergency spillway outlet (looking downstream) features a plunge pool with boulder riffles and riprap channel lining downstream to maintain a depth of 5 feet.
