Monitoring restored wetland sites for long-term quality

Featured Project

Location: City of Grant, Washington County

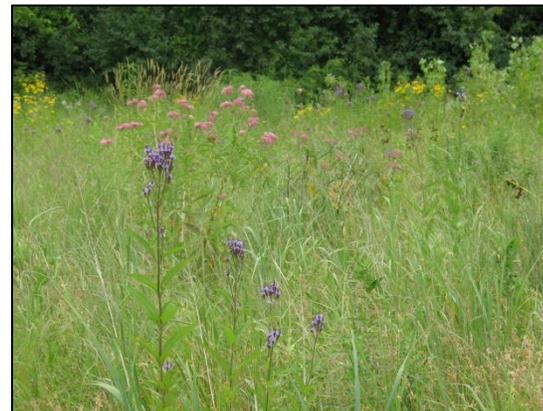
Pictured: The restored wetland includes a buffer that consists of a diverse mix of native grasses and flowers (above), whereas the mowed buffer (below) prevents the wetland from achieving the intended benefits.

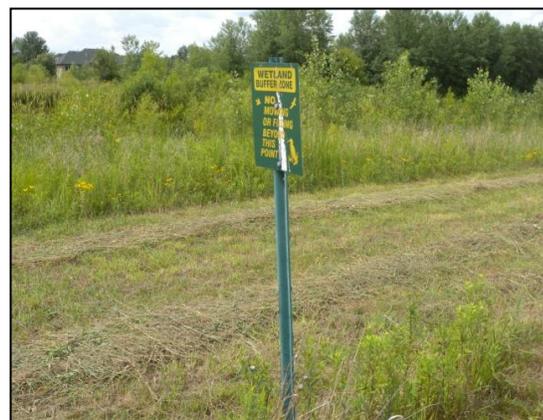
An example of recent easement compliance work involved unauthorized mowing within an easement established in 2001. Part of the easement area lacked signage to identify the boundary, and the property had changed ownership, which led to uncertainty about the landowner's responsibilities in the terms of the conservation easement. The grass buffer, surrounding a restored wetland, was routinely being mowed and hayed by vendors hired by the landowner and the homeowner's association. The mowing degraded the wetland vegetation and negatively affected the intended improvements to water quality and wildlife habitat.

In 2010 BWSR's monitoring staff again contacted the landowner and homeowner's association to reestablish the easement boundary corners and to explain why the mowing within the development was harmful to the restored wetland and in violation of the easement. In 2011 monitoring staff will meet with other landowners in the development with identified mowing violations to reestablish their easement boundaries and to allow native vegetation to regenerate.

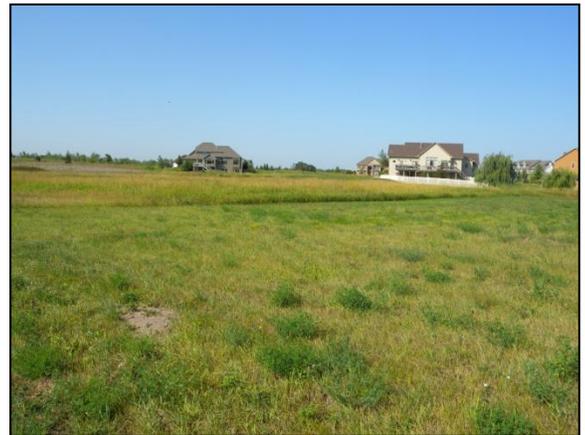
This mowed wetland buffer prevents vegetation from getting established, and in turn providing multiple benefits for water quality and wildlife habitat.
